# RESEARCH LABORATORY TECHNICAL REPORT

## Sidewalk Repair Near Trees

By The Bartlett Lab Staff  
Directed by Kelby Fite, PhD

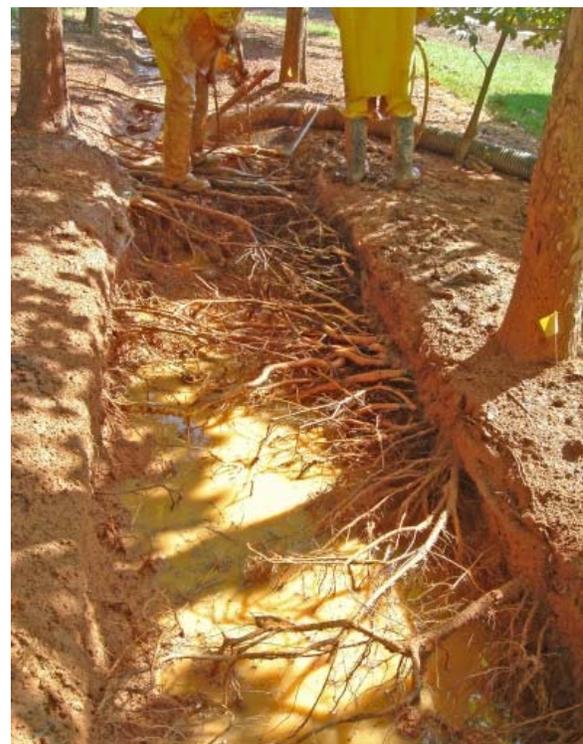
Bartlett Lab research plot showing different root growth patterns with no base layer (upper) and where foam board was installed (lower).

Modifications that will extend the useful life of sidewalk pavement include installation of root barriers alongside the pavement or installing a root-excluding base beneath the concrete. Root barriers must be at least 18 inches (45 cm) deep and the top must be above the soil and mulch surface to be effective. Base layers that successfully exclude roots include washed coarse gravel (1-1.5 inches, 2.5-3.7 cm diameter, with no fines) and foam insulation boards. A gravel base at least 4 inches (10 cm) thick is recommended, thicker is probably better. Gravel is only effective in well drained soils. Foam boards are commonly available from ½ to 2 inches (1.25 to 5 cm) thick. Two 2 inch (5 cm) thick boards can be glued together to provide a 4 inch (10 cm) base for the greatest protection from root growth damage.

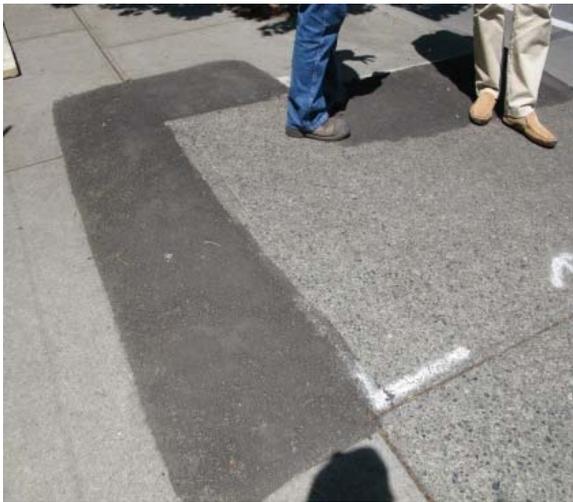
Asphalt ramp/wedge installed to reduce tripping hazard.

**1. Shaving the top of the concrete or installing a ramp** to even the surface and reduce the tripping hazard. Shaving or grinding the concrete is done with a specialized cutting machine. The goal is to lower the raised concrete edge to the level of the lower slab. Concrete can be ground to about ½ of its original thickness. The other commonly used alternative is to install a ramp or wedge of asphalt or concrete to smoothly bring the lower level up to the lifted edge.

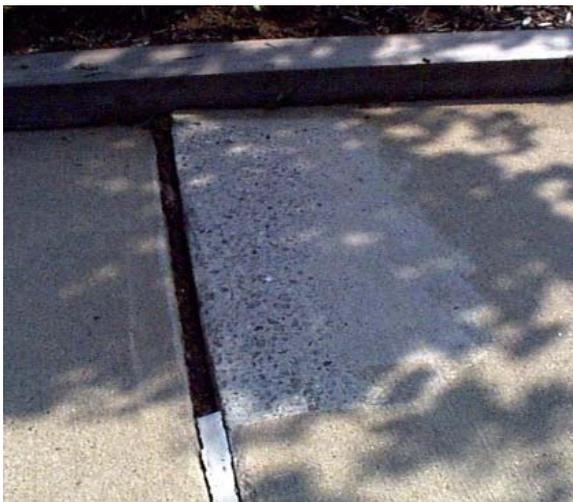
Concrete shaved/ground to smooth.

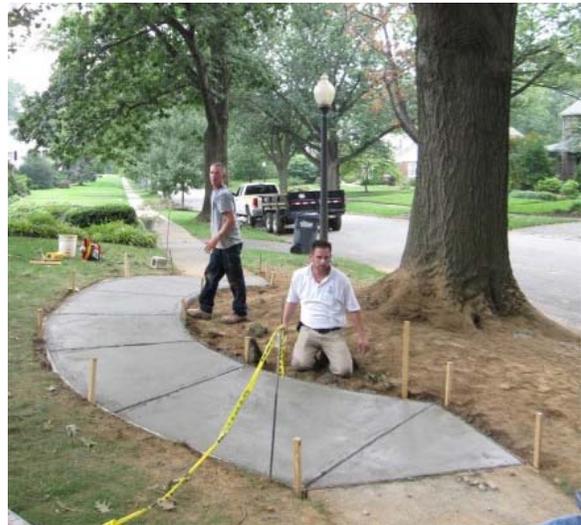
Sidewalk rerouted to increase the distance from the trunk and avoid root damage.

**2. Increasing the distance from the tree to the edge of the sidewalk.** This can be done by either narrowing the sidewalk or rerouting it around the tree. The Americans with Disabilities Act (ADA) limits sidewalk width to no less than 39 inches (1m). By increasing the distance from the sidewalk to the trunk, the roots that are most likely to cause damage will no longer be underneath the pavement. Sidewalks can often be curved around a tree with the permission of the property owner. These techniques can avoid damage to large roots that are primarily responsible for tree stability.

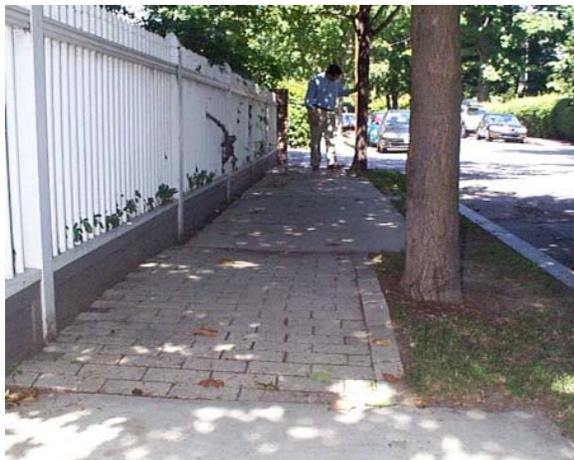
Sidewalk narrowed and pavers installed to provide more room for root growth.

**4. Replacing concrete with interlocking paver blocks or rubber pavers.** This alternative will not slow pavement lifting, but will allow for a smoother transition and the removal of blocks that have lifted too high. Pavers are installed by removing the concrete and base materials above the roots and removing the soil between the roots if needed using a supersonic air excavation tool, installing a new sub-base of coarse sand or pea gravel, leveling and compacting the sub-base slightly above the existing roots, install a geotextile fabric (e.g. Typar 3341) on top of the base, then installing and compacting a coarse sand base layer, and finally installing the pavers. Paver joints should *not* be mortared.

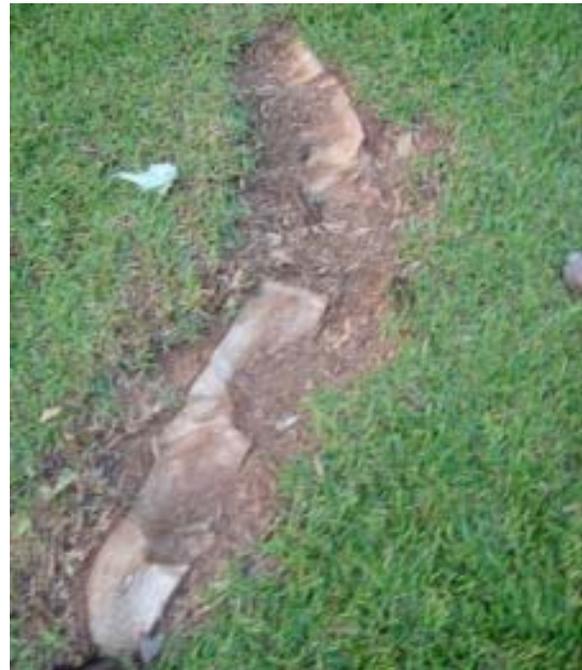
Root top shaved to lower the surface.

**5. Root shaving then installing new concrete.** If the pavement must be reinstalled flat and in the same location from which it was removed, the height of the offending roots will need to be lowered. For mature trees, it is best not to cut roots greater than 2 inches (5 cm) in diameter. However, it is usually roots that are larger than this that create sidewalk lifting problems. It is better to remove the top surface of a root rather than the entire root. This is done by shaving the root using a chainsaw or debarking tool. Large roots should not be cut more than 1/3 of their diameter. Cut roots do tend to callus quickly, so a layer of rigid foam or pipe insulation foam should be installed between the shaved root surface and the new concrete. The loss of tree stability from root shaving and the rate of decay in shaved roots are not known. The tree should be inspected annually for health and stability if shaving is done closer than three times the trunk diameter (DBH) from the base of the tree.

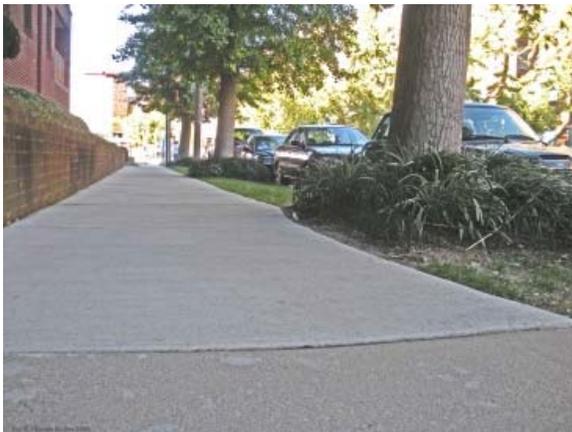
This new smooth and level sidewalk required root cutting.

**6. Root removal and sidewalk replacement.** The removal of roots at the edge of the sidewalk followed by concrete replacement will provide a longer term solution to sidewalk lifting but will have the greatest

effect on tree health and stability. A thorough tree structural analysis should be conducted before roots are removed. It is recommended that buttress roots not be cut closer to the trunk than a distance equal to three times the trunk diameter (DBH). If they need to be severed closer than 1.5 times trunk diameter, tree removal should be considered since it is very likely that tree stability will be affected at this distance, depending on tree species and condition. When reinstalling the pavement next to a root cut tree, allow space for callus and trunk diameter growth. Installation of a root barrier or root excluding base (foam board or washed gravel) should also be considered under the new pavement to avoid reoccurrence of the problem.
